1.1 Novel Solution #7 - Reflective floor insulation (Delft pilot)

1.1.1 Location in building - Delft

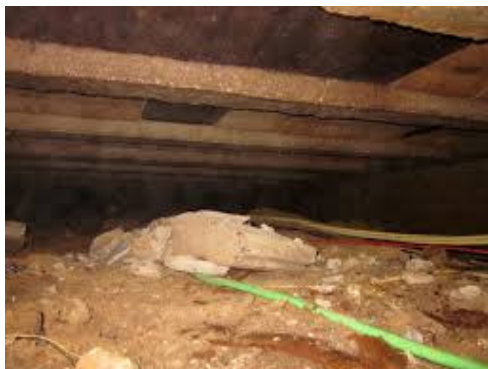
Before the start of the project there was no insulation underneath the floor.

Figure 2: Typical crawlspace. Source Woonbron

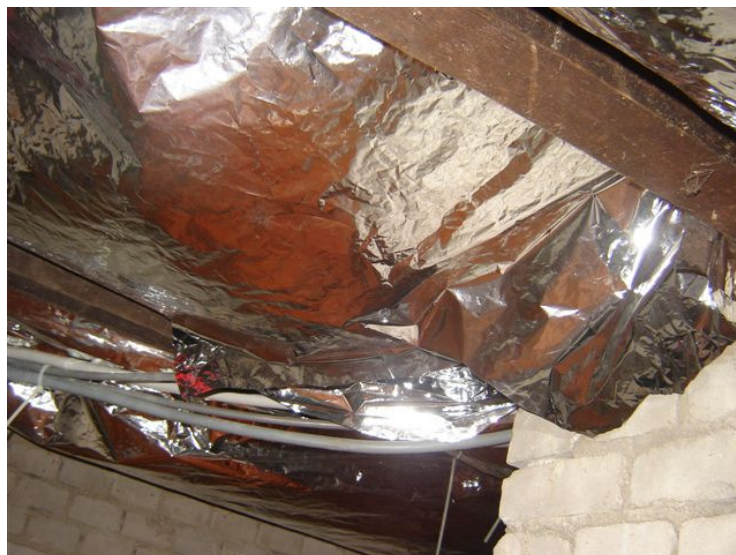
There are other projects in the portfolio of Woonbron however where it has been shown that it is very difficult to install the Tonzon insulation in the best way, leaving doubts about value in the very complicated situations (for example in a very narrow crawl space, or in situations with many beams and pipes).

Figure 5: Picture of the actual project. Source: Evert Hasselaar / OTB
