## Building Energy Efficiency for Massive market Uptake

Beem-Up assessment of energy  
efficient performance and indoor  
environment in all 3 sites

## Deliverable D.3.9

Assessment of energy efficient performance and indoor environment in all 3 sites

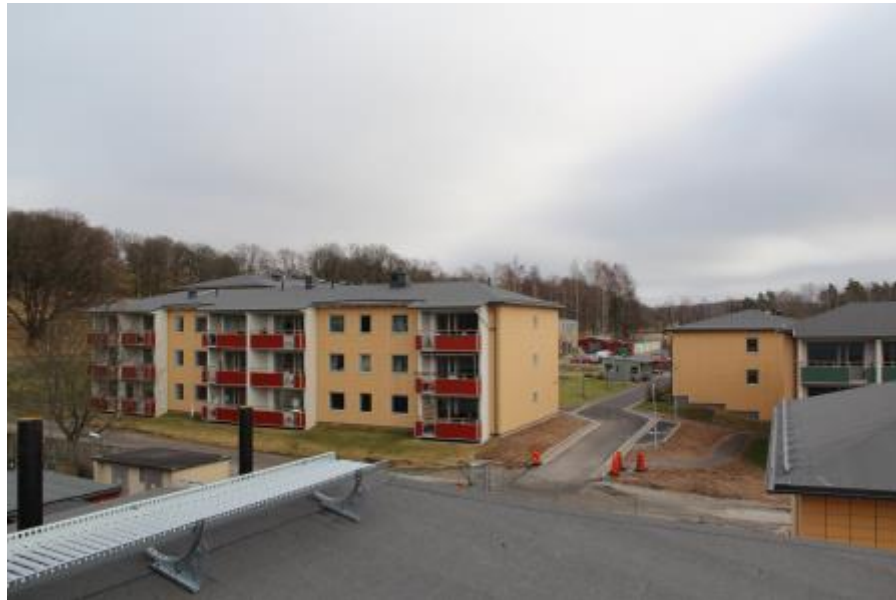
**Figure 1: Pilot site in Alingsås**

a) A renovated building in front of the photo, building that has not yet been renovated in the back.

b) House H during renovation.

c) Facades and roofs of buildings B, C, F, G and H as seen clockwise

Within the BEEM-UP project, one house has been selected for monitoring. The house holds 18 apartments on 3 floors and has a south facing façade. The size of the apartments varies from 1 to 4 rooms + kitchen per dwelling. The house is called “building H” within the BEEM-UP project. The monitoring of the building is done both on building level as well as more in detail for four of the apartments (see deliverable D 3.3, [ 1 ]). This building has also a shared laundry room. The following pictures show the renovated buildings as well as the House H during the renovation process in Alingsås.

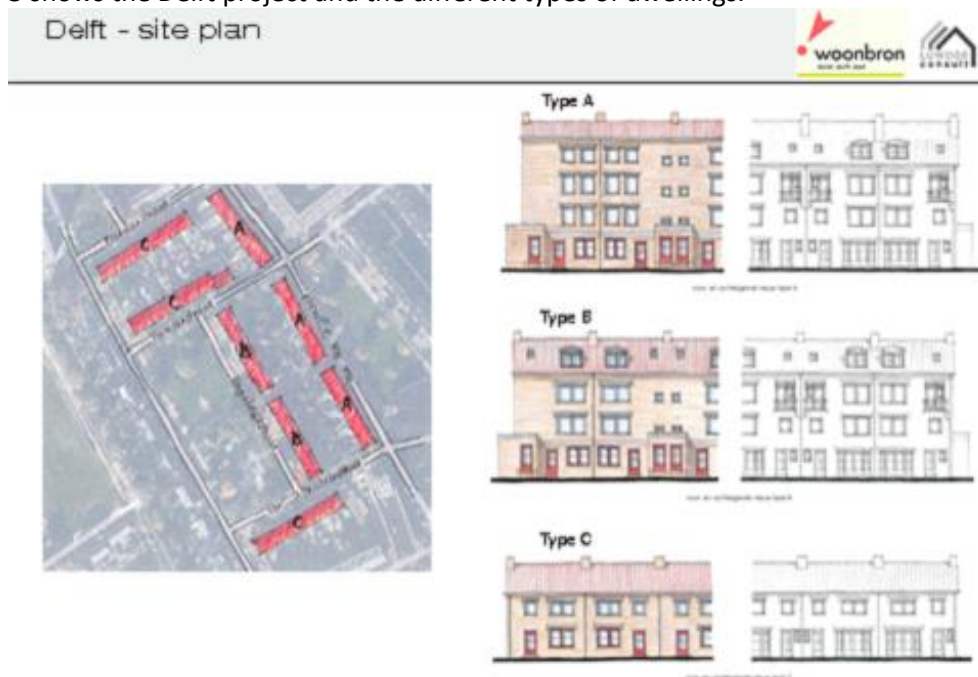
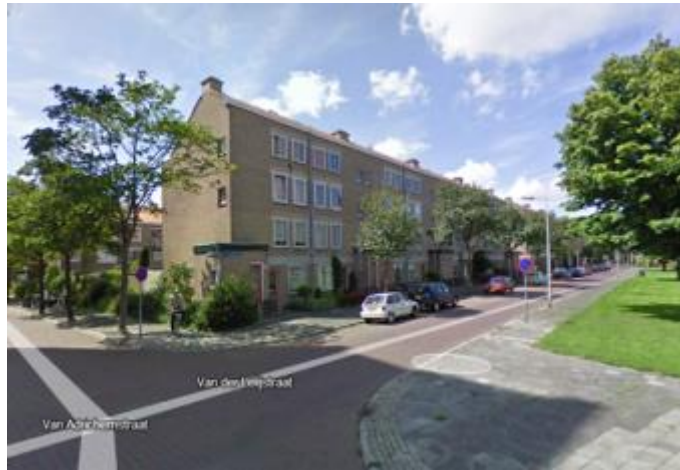
Figure 3: The Delft project has 3 types of houses in 8 blocks.

The Figure 3 shows the Delft project and the different types of dwellings.

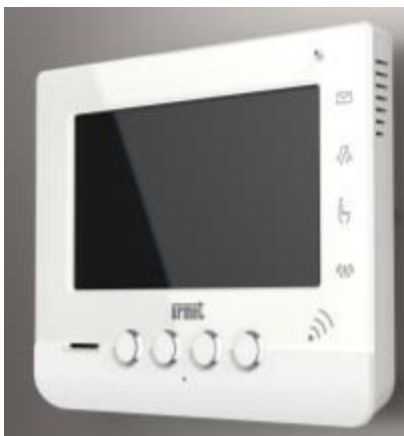
Figure 6: Examples of displays used in the feedback system installed in Paris site

In Paris, the energy feedback system is multifunctional including the door opener function (integrated in a videophone service) as well as the display of energy consumptions ( Figure 6). Data on daily consumption as well as on accumulated consumption is available on the display. The system also enables the building owner NOVEDIS to communicate with the tenants. During the interviews, the feedbacks related to the feedback system are mitigated. Some of the tenants report that the functioning is not easy to handle. The thermostat seems not to be used by the tenants mainly because of the difficulty to use it in a simple way (lack of operating instructions). Whereas the individual thermostats attached to the radiators seem to be intensively used by the tenants, and that seems in good correlation with the indoor temperature management observed in the monitoring process [ 5 ].
