Building Energy Efficiency for Massive market Uptake

Beem-Up assessment of energy
efficient performance and indoor
environment in all 3 sites

Deliverable D.3.9

Assessment of energy efficient performance and indoor environment in all 3 sites

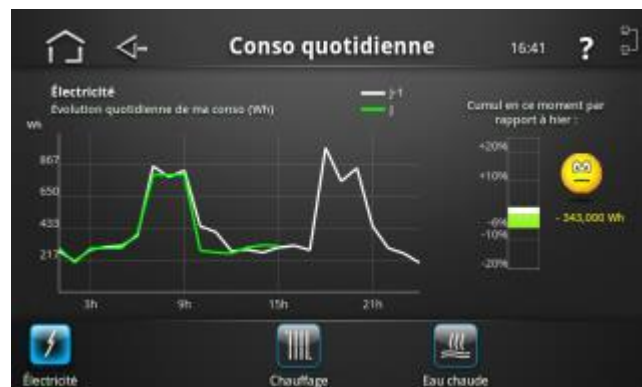
In Paris, the energy feedback system is multifunctional including the door opener function (integrated in a videophone service) as well as the display of energy consumptions (Figure 6). Data on daily consumption as well as on accumulated consumption is available on the display. The system also enables the building owner NOVEDIS to communicate with the tenants. During the interviews, the feedbacks related to the feedback system are mitigated. Some of the tenants report that the functioning is not easy to handle. The thermostat seems not to be used by the tenants mainly because of the difficulty to use it in a simple way (lack of operating instructions). Whereas the individual thermostats attached to the radiators seem to be intensively used by the tenants, and that seems in good correlation with the indoor temperature management observed in the monitoring process [5].

Figure 6: Examples of displays used in the feedback system installed in Paris site
